MEASURING STRENGTH INCREASE OF REMOULDED SENSITIVE CLAY FROM THE GJERDRUM LANDSLIDE, NORWAY

ABSTRACT

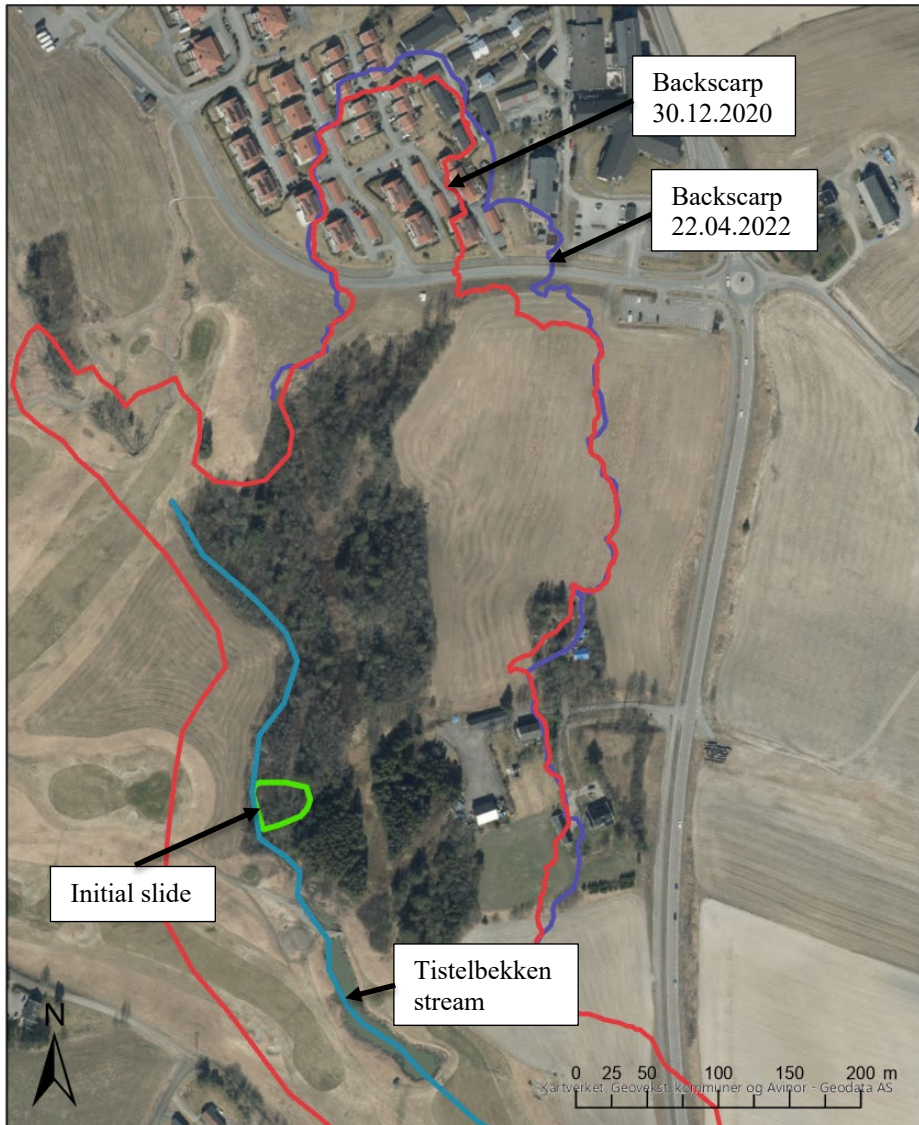
The cause of the landslide was later investigated by an independent commission [4]. The landslide was found to have initiated in a tall, steep slope approximately 400 m south of the residential area (Figure 1) and was triggered by erosion in the stream. The initial slide was probably small and triggered a series of larger retrogressive slides that moved up the slope and developed northwards and sideways, eventually reaching the residential area. Much of the slide material consisted of quick clay, and the soil structure collapsed upon failure, becoming liquid flowing out of the slide area.

Figure 1. Aerial photograph of the landslide area in 2020 before the landslide occurred (source: Kartverket). The approximate location of the initial (triggering) slide is shown in green. The extent of the backscarp and run-out area on 5th January 2021 is shown in red, and the backscarp on 28th January 2022 is shown in blue. The runout area extends 2 km further to the south; thus, the full extent is not shown here.

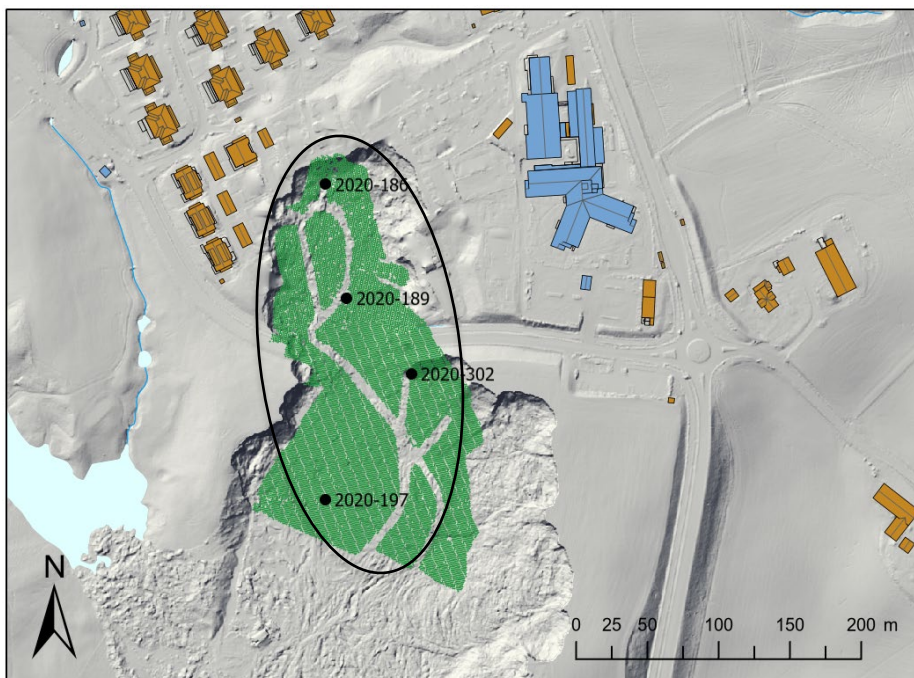
Figure 2. Digital terrain model created from laser scan conducted on 14th January 2021, two weeks after the landslide. The area with site investigation results included in this report is indicated with a black oval. Precise locations are provided for four specific boreholes that are discussed later in this article. Plastic vertical drains were installed in the green area in 2022.

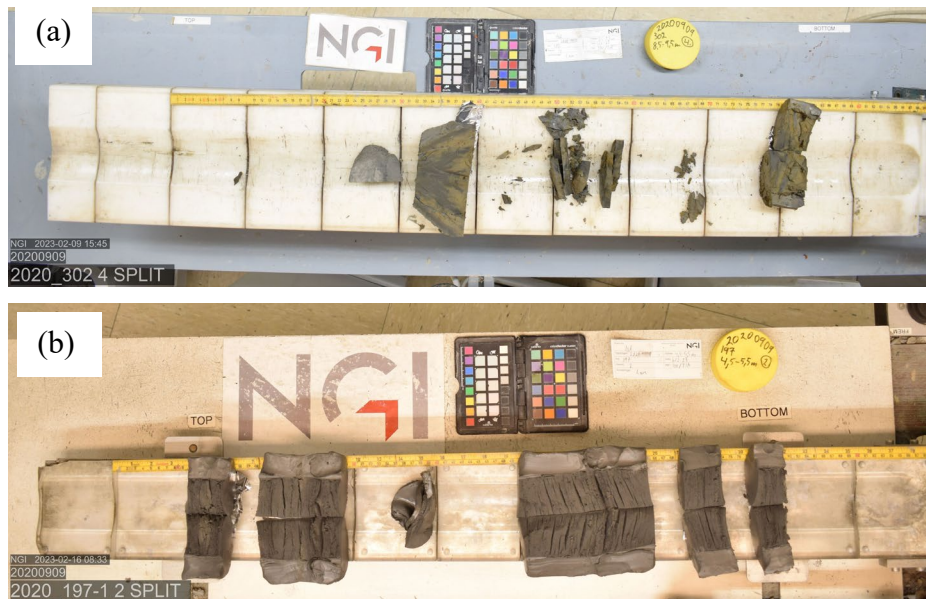
- clay,
- consistency varies from very soft to firm,
- colour is dark grey,
- often described as silty,
- some samples have inclusions of dry crust (Figure 3a),
- some samples have silt layers or layers of fine sand,
- some samples are described as laminated (Figure 3b).

Figure 3. Piston samples. Examples of (a) dry crust intrusions, (b) laminated clay.

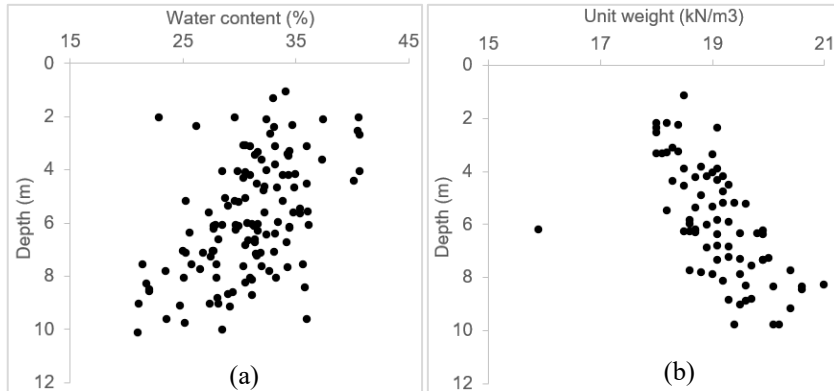
Figure 4. a) Water content (w) and b) unit weight (γ) for samples of slide material

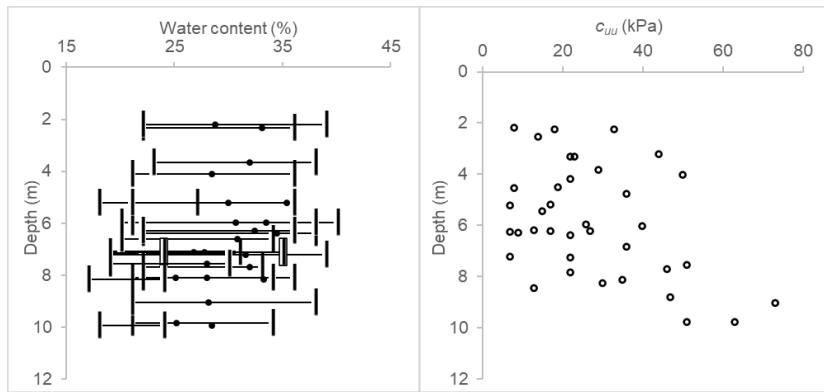
Figure 5. Atterberg limits and natural Water content for the slide material.

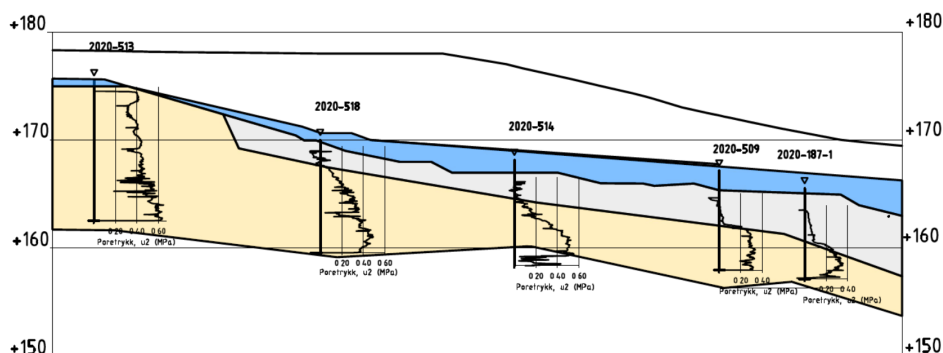
To evaluate the properties of the slide material, it was first necessary to determine where the slide surface was located. It was possible to localise the transition between slide material and intact clay level by interpreting CPTu results. Figure 8 shows an example of interpreted layering, where the grey layer is interpreted as slide material. Only the pore pressure response (u_2) is shown, and from the figure it is clear that the intact clay has a higher excess pore water pressure response than the remoulded material. This pore pressure response was also reflected by a sudden increase in the pore pressure parameter, B_q . Similar interpretation of CPTu-data has been used to determine the interface between intact and remoulded material, e.g. [9].

Figure 8. Example of terrain profile in the slide area. The yellow layer is clay (not quick clay, but still sensitive). The grey layer is the slide material. The blue layer is either counterfill or intact dry crust.

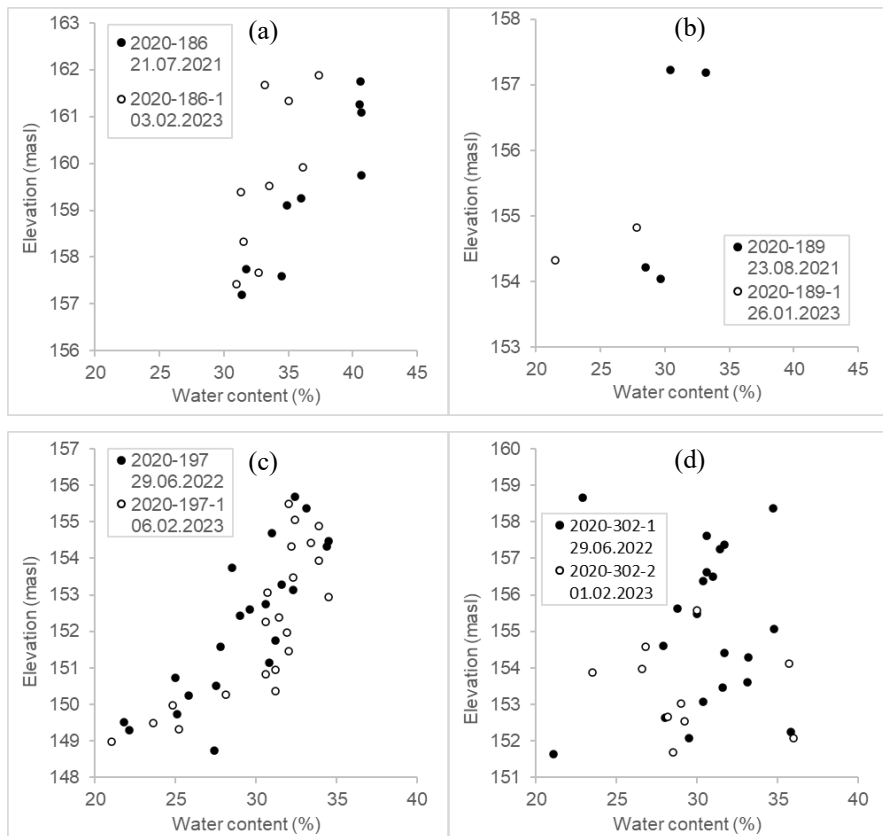
A decrease in water content is apparent in borehole 2020-186 (Figure 9a). This decrease in water content is expected, as the slide material consolidates, and excess pore water pressure dissipates. The other locations with repeat sampling, boreholes 2020-189, 2020-197 and 2020-302 (Figure 9b-d), do not exhibit a consistent reduction in water content. The most probable reason for this difference is the installation of PVD: only borehole 2020-186 had samples taken prior to installation of PVD, and thus the material in borehole 2020-189 was still under-consolidated for the samples in July 2022. For the remaining boreholes, the PVD have sped up consolidation, and by the time of the first round of sampling, primary consolidation was most likely already well underway or completed.

Figure 9. Change in water content with time for four borehole locations: a) 2020-186, b) 2020-189, c) 2020-197, d) 2020-302. The date of sampling is indicated for each sample.

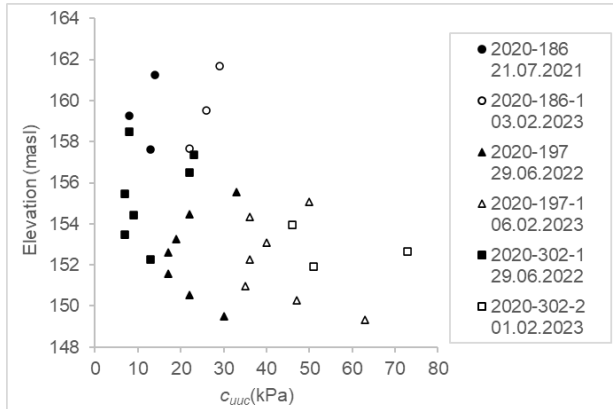
Figure 10. Undrained shear strength from unconsolidated, undrained tests on slide material against elevation. The date of sampling is indicated for each sample.

All samples displayed a strength increase of at least 10 kPa over time. Surprisingly, the samples with the longest time between samples (sampled at borehole 2020-186) resulted in smaller changes in undrained shear strength than samples with a longer time interval. Samples from borehole 2020-186 had a clear reduction in water content during this time period (Figure 9a), therefore it is unexpected that they exhibited the lowest increase in undrained shear strength. Possible reasons are a shorter time period with PVD, later application of the counterfill or differences in material type.

The change in undrained strength for boreholes 2020-197 and 2020-302 were larger, even though the time interval between sampling was smaller. These boreholes were located further south in the slide area and had the PVD installed earlier. Borehole 2020-302 also had a larger counterfill applied before the second round of sampling (Table 2). This indicates that the effective stress conditions should also be considered, and this hypothesis could be further strengthened by assessment of the pore pressure measurements at the time of sampling, and investigating when each counterfill was placed. Note also that borehole 2020-197 is the only borehole that is totally surrounded by PVD. Other boreholes were located on the edge of construction roads, where it was not suited to install PVDs.
