CEMENTSTABILIZATION OF PEATMATERIAL IN ROAD CONSTRUCTION

Kristoffer Lauridsen¹, Andreas Elkjær Riis¹

Rv. 4 Roa – Gran grense is a 4.2-kilometer long motorway project that aims to replace the existing two-lane highway with a four-lane motorway between Roa and Gran grense in the southern part of Norway. The project includes the construction of six bridges, one culvert, extensive rock and soil cuts, and significant landfills. The ground conditions in the project area vary greatly, ranging from peat and till to areas with quick clay, moraine, and thin layers of gravel over bedrock.

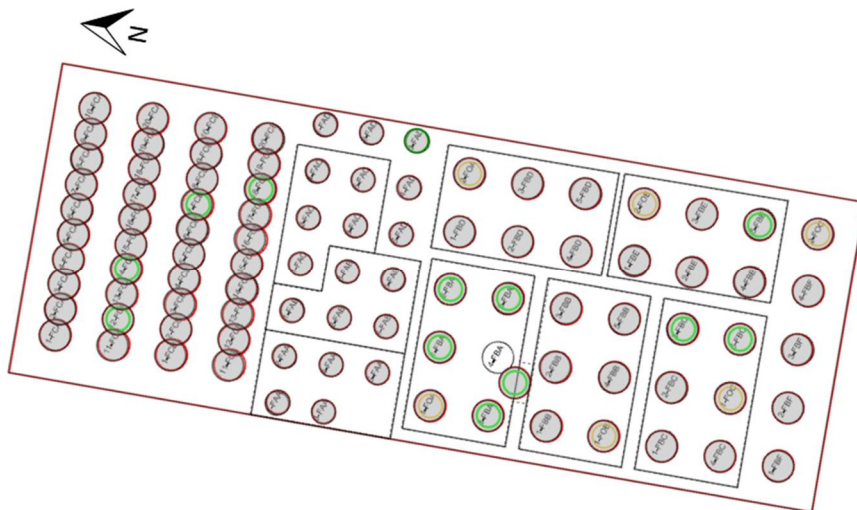
Figure 6 Test area for stabilization.

The test field consisted of both single piles and interlocked pile rows, utilizing various pile diameters, amounts of material, and installation speeds. A sketch of the test area is presented in Figure 6. A total of 95 piles were installed. To evaluate the impact of the quantity of material used, pile diameter, installation method, and the time elapsed between installation and testing, a test schedule

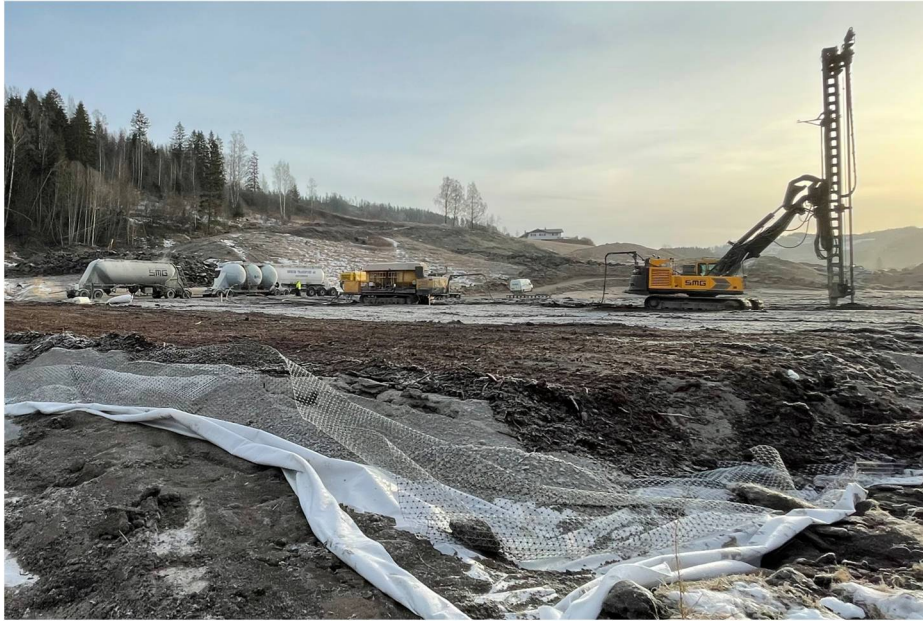
Figure 7 Soilmixing performed by SMG. Credit T. Bjørhusdal.

The installations of the cement and the FKPS testing were performed by Soil Mixing Group AB (SMG), as can be seen in *Figure 7*.

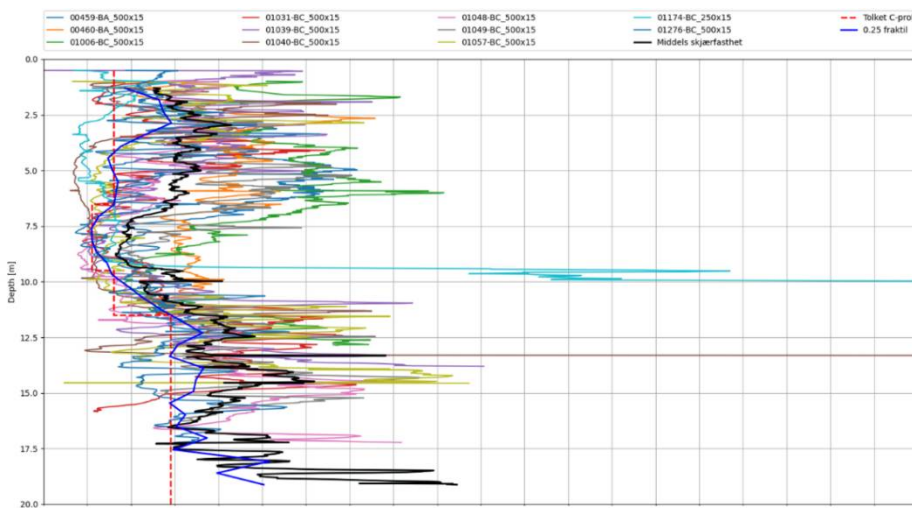
Figure 9 Measured strength distribution with depth including assed design profile.

Results of the FKPS test in the southern part of the area showed consistent results as can be seen in *Figure 9*. The following monitoring also found that the settlement curves in the course of 3 months were starting to level out, as can be in *Figure 8*, with settlements ranging from 0 – 12 cm.

In the northern part of the stabilized area, a significantly larger scatter was observed in the achieved strength parameters, as depicted in Figure 9. Furthermore, it was noted that the attained strength parameters did not meet the expected values. To address the lack of strength in certain piles, additional piles were added, and an extended period of pre-loading was implemented. As shown in Figure 10, a wider range of measured settlement, ranging from 2 cm to 25 cm after 2 months, was observed.
