CHALLENGES IN DETERMINING GROUND CONDITIONS FOR THE DESIGN OF WATER RESERVOIR DAMS IN THE AITIK MINE

Boliden Mineral AB contracted Golder (now WSP) for the investigation for and the design of three new water reservoir dams near the tailings area in the Aitik mine. The dams have crest lengths of approximately 3,7 kilometers and a height ranging from 20 to 25 meters. One of these dams will reach approximately 50 meters in height following tailings deposition. To determine the ground conditions geotechnical investigations were conducted. The investigations included test pit excavations, sondes (Jb-Tot, Jb-2, HfA) including sampling in soil, core drilling in rock, as well as laboratory tests and hydrogeological tests. The investigations were carried out during the years 2017-2020, with a total of over 365 days at the field.

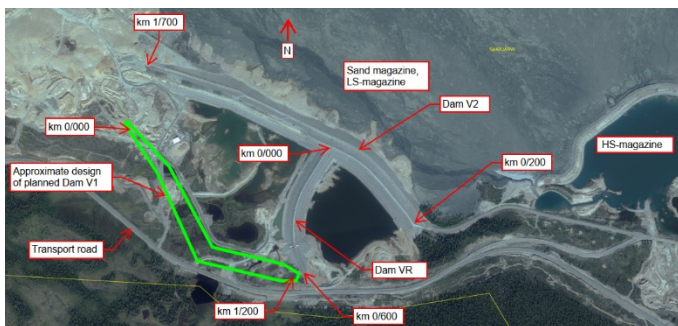
Figure 1. Orientation figure with approximate length measurement for dam V1, V2, and VR [11].

Boliden, in accordance with the current permit [1], has committed to the construction of a new reservoir, the HS reservoir, for the deposition of high-sulfur enrichment sand, a purification plant, and a new Water Reservoir, see Figure 1. The purpose of the reservoir is to manage the water flow from the HS reservoir, increase the water storage capacity in the system, to reduce the amount of water discharged to the recipient, and to better control when water is to be discharged.

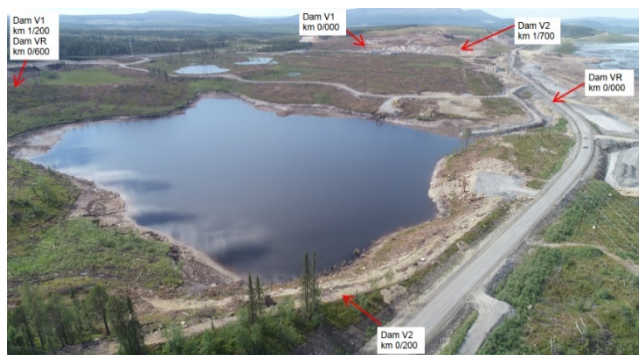
Figure 2. Drone photo over the dam area, to the right of the road you can see the construction of the dam V2 [12].

Most of the investigation area has been covered with fir and pine forest, which is now felled, but also marsh areas and smaller ponds exist, see Figure 2. The vegetation and soil layer varies between about 0,6-1,0 m.

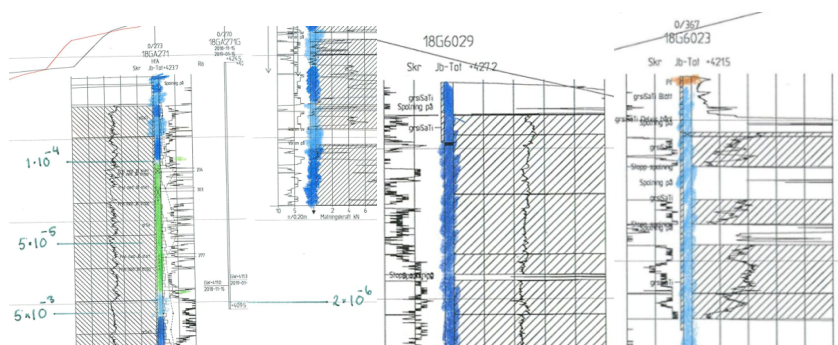
Figure 4. Examples of interpretation of soundings. To the left, interpretation of sounding with sampling, HfA and Jb sounding incl. K-value; middle, interpretation of sampling and Jb sounding; to the right, interpretation of sampling and Jb sounding

In Figure 4 below, an example of how the interpretation has been reported is shown. The interpretation of these three soundings differs. For the left sounding, there is screw sampling, HfA, and Jb sounding. In the left sounding, mainly screw sampling and HfA results are used and the interpretation is more simple. In the other two soundings, there is only screw sampling and Jb sounding, but the interpretation is more difficult in the right one because the feed force, sinking rate, and hammer drilling vary.

In the left sounding, there are also hydrogeological falling-head tests performed and in the associated groundwater pipes slug tests are also performed. Hydrogeological tests have mainly been performed where screw sampling has shown a high proportion of sand and/or gravel and that low relative strength has been measured in soundings.
