FOUNDATION ON ORGANIC DIATOMITE

J. D. Andersen, L. Bødker, J. Dolby, A. Damsgaard and N. Okkels¹

This article is initiated by a project in Vejle in Denmark, where a sewage treatment plant in 2023 was to be enlarged by a new tank and an adjacent pumping station.

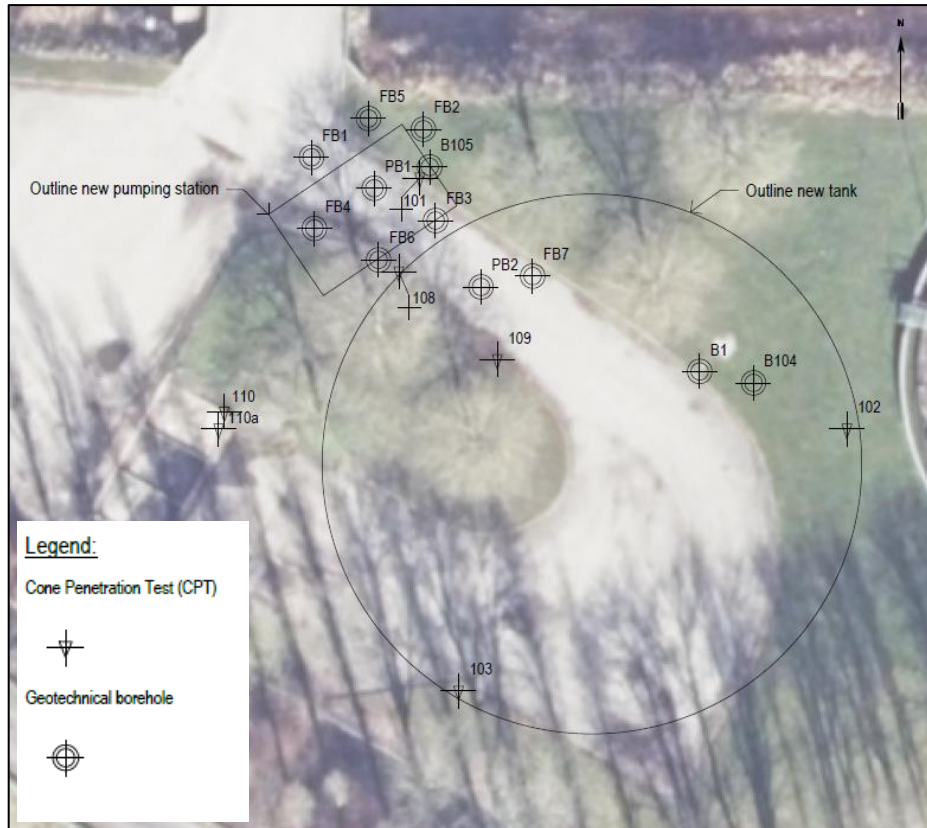
Figure 1: Site plan with borings and CPTu's.

Afterward, Geo performed a geotechnical parameter investigation for the project, as shown in Figure 1 (ref. 3). First, three Cone Penetration Tests (CPTu 101 – 103) were performed at the perimeter of the tank area, where a penetration depth of 30 meters was presumed sufficient and abundant. The evaluation of the CPTu's showed some severe variations in the layering and soil firmness compared to the initial boring. It was found necessary to supplement these

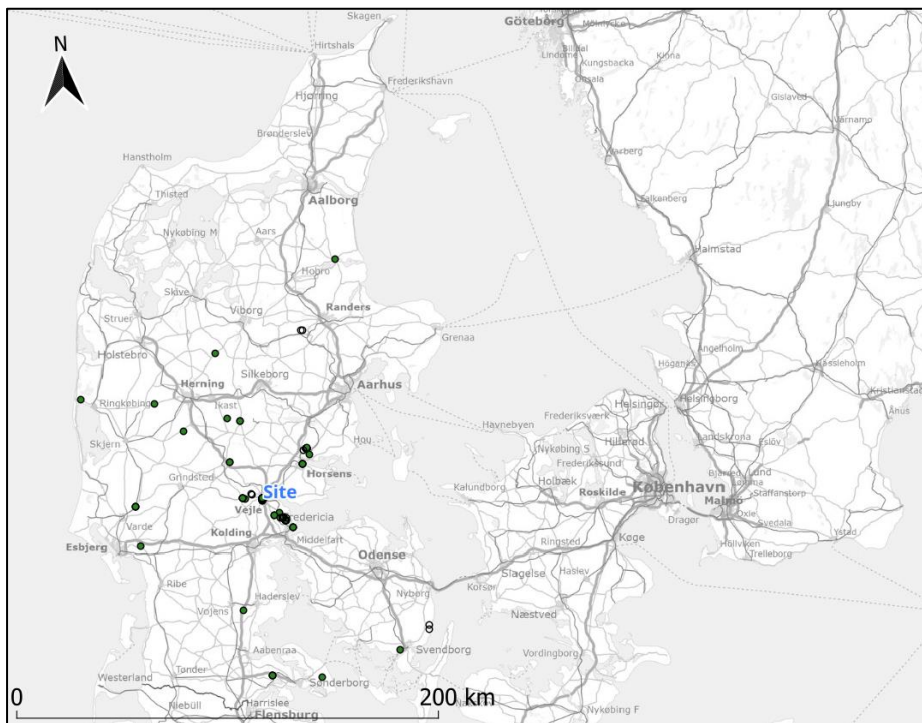
Figure 2: Location of boreholes with interglacial and interstadial freshwater diatomite in Denmark according to the GeoAtlas Live database (green dots), combined with locations of known diatomite pits (open rings). The site location (Figures 1 and 3) is marked with blue text.

In Denmark, freshwater diatomite is found in south-western, see Figure 2, deposited as non-calcareous sediments from differing interglacial or interstadial periods and as marine deposits from the geological Paleogene period in the north-western part. Diatomite is a fine-graded, biogenic sediment that predominantly consists of shells from microscopic algae, also called diatoms. Diatom shells are a so-called opal-A, a silicate with very high water content in the chemical form $\text{SiO}_2 - n\text{H}_2\text{O}$, an inorganic biogenic material. Pure dry diatomite is able to float on water due to its high porosity. Natural diatomite deposits contain variable levels of finely divided organic material and minerals of silt and clay, typically deposited during winter periods between summer algae blooms. If the geotechnical characteristics of the sediment are dominated by high organic content, it is tradition in Denmark to use the term diatomite gytja.
